The retaining wall collapse prevention during the multifunctional complex construction on the slope of Staronavodnytska ravine in Kyiv

Research Institute of Building Constructions

Mediterranean
Symposium
on Landslides

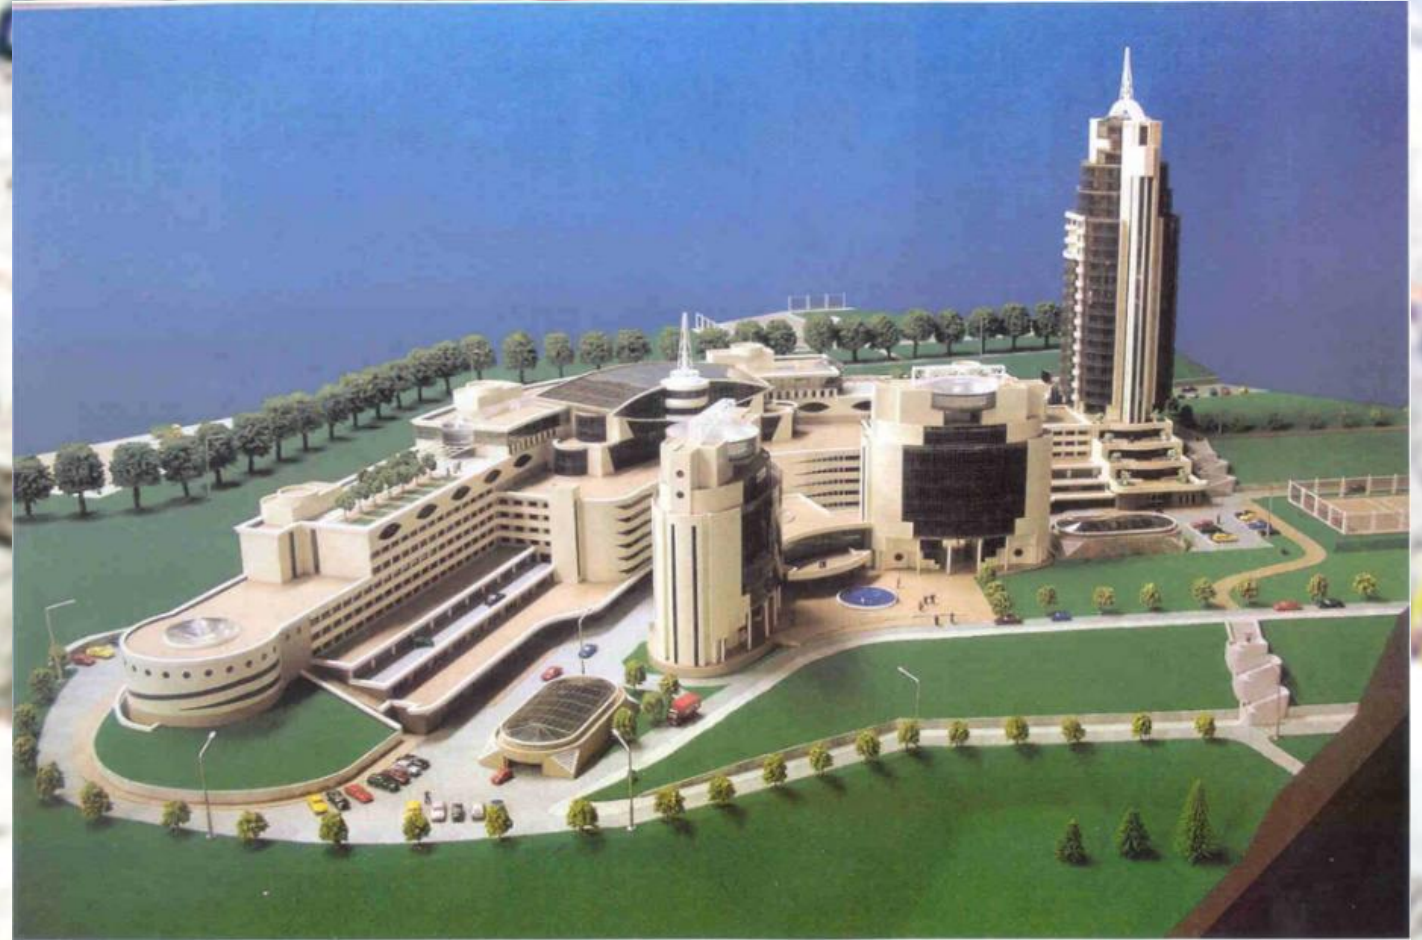
Multistorey garage at 2-20 Staronavodnytska Street in Kyiv is the buildings and structures complex for cars storage, repair and movement, the administrative and auxiliary purposes buildings, as well as the engineering structures in the form of retaining walls. In terms of geomorphology, the site for the designed multistorey garage is located on the right slope of the ancient Staronavodnytska Ravine (Fig. 1).

Fig.1. General view of the multifunctional complex on the Staronavodnytska Ravine slope

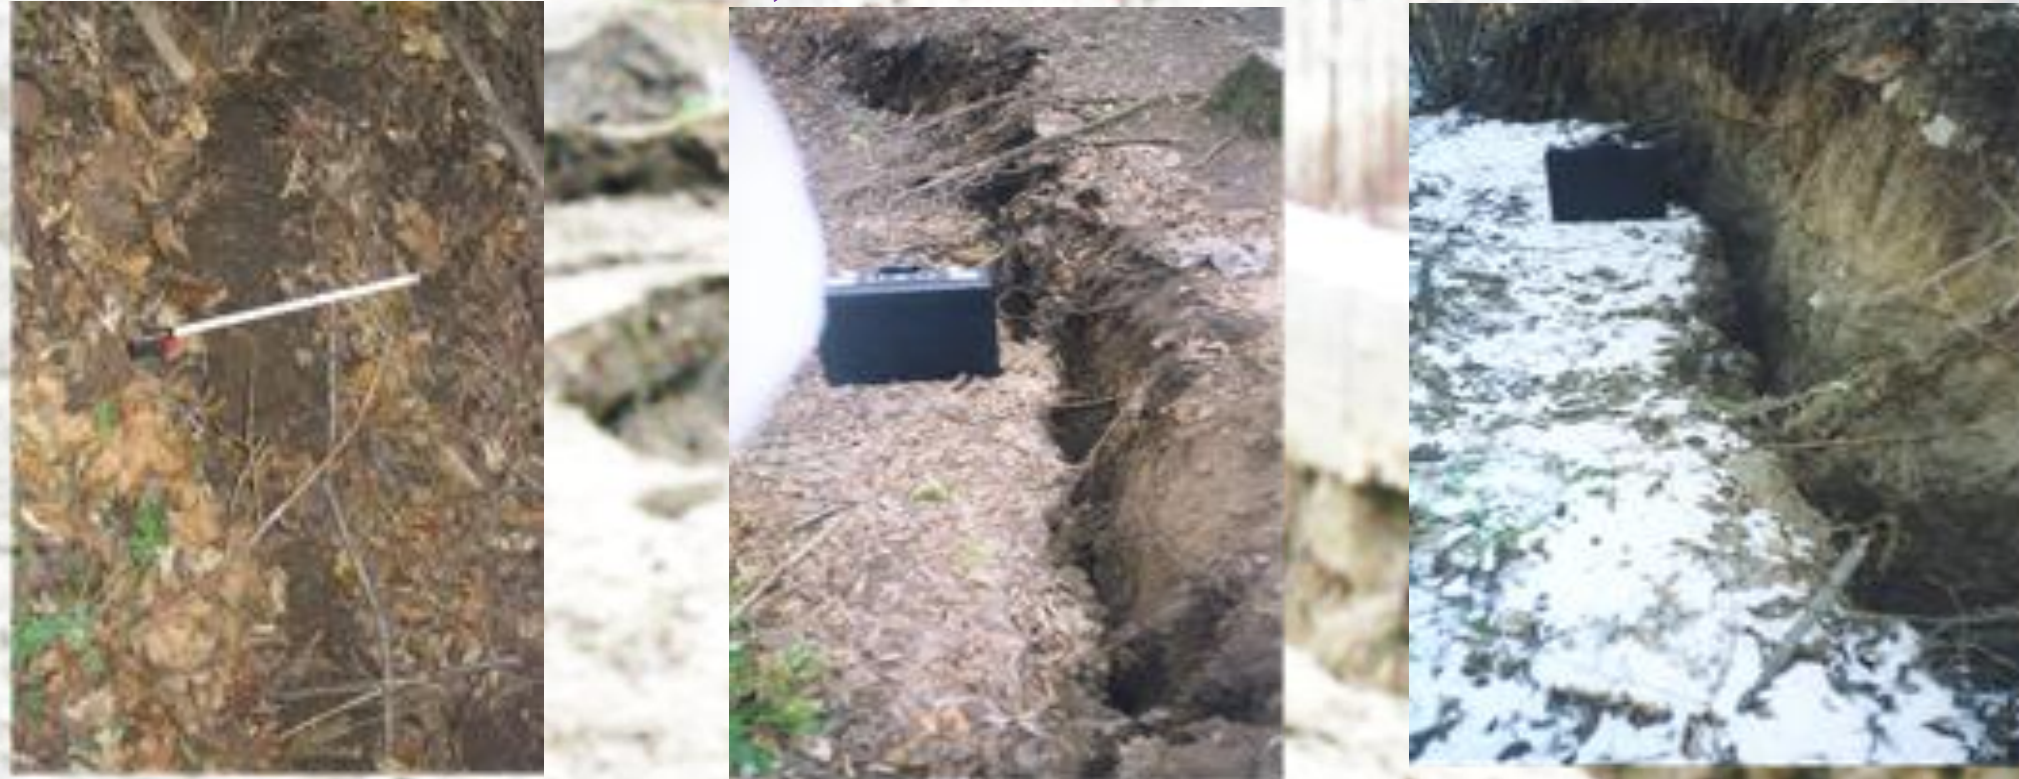
That meant that a shear body had formed on that portion of the slope. It was clearly indicated by the crack of stabbing, which appeared higher on the slope and increased in time, plan, and depth. Detailed photographs of the stabbing crack above the land-slide protection structures on the slope beyond the Y'' axis as of 28.11.2003, 14.12.2003 and 21.12.2003 are shown below.

Fig. 2. – Stabbing cracks above the LPS on the slope as of: 1) 28.11.2003; 2) 14.12.2003; 3) 21.12.2003

As a result, a shear body was formed in the 5... 12 axes, which was clearly indicated by the stabbing cracks appeared higher on the slope beyond the Y axis (Fig. 2). Moreover, the through cracks with opening widths up to 60 mm emerged in the ground beam along the Y/35...37 axis (Fig. 7).

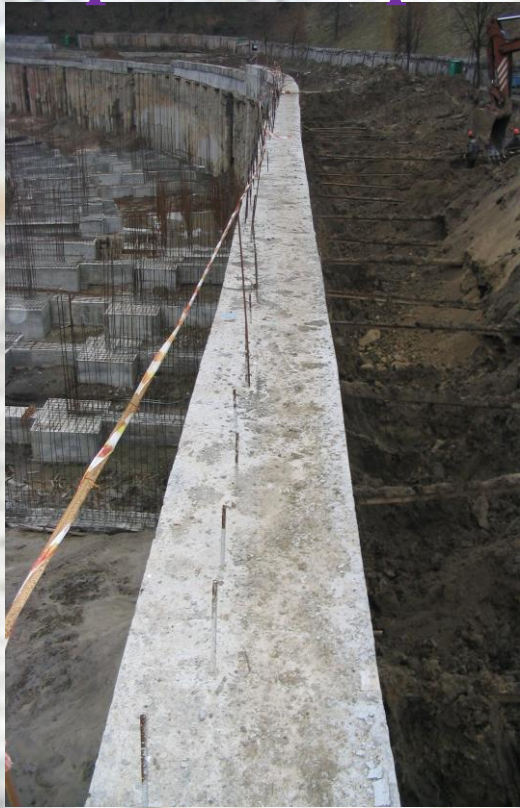
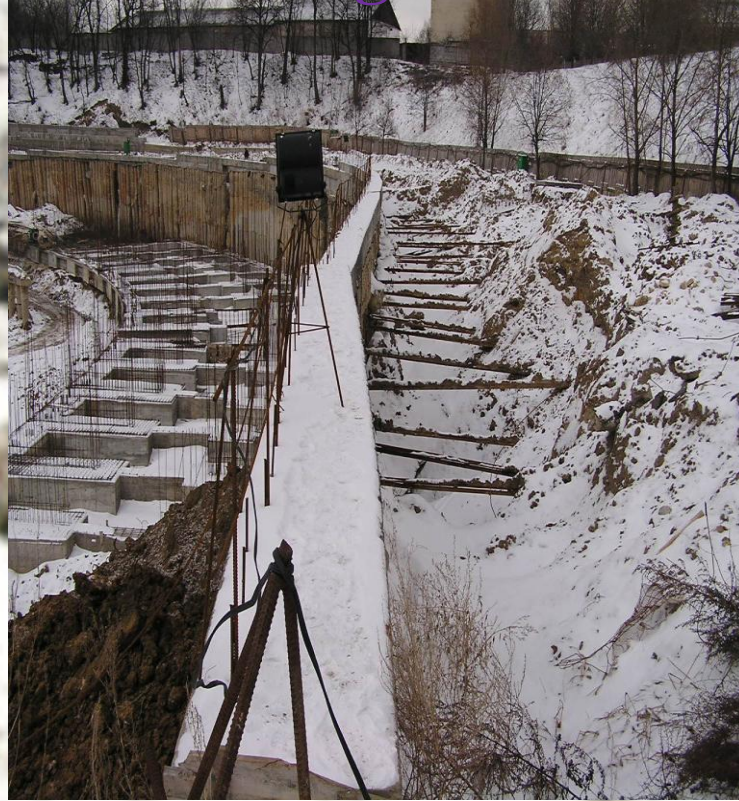
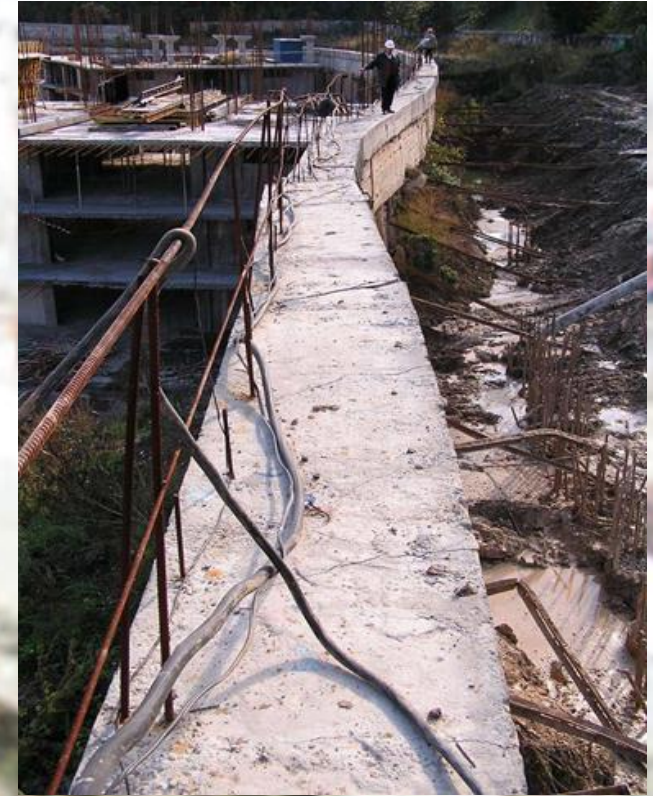
The deformations ("bending" under the shearing pressure action) of the garage complex fence piles ground beam along the Y axis in the 31 ... 39 axes are shown below.

A). State as of 28.11.2003 г.

B). State as of 17.02.2004 г.

C). State as of 13.10.2004 г.

Fig. 3. Soil accident: deformations ("bending" under the shearing pressure action) of the garage complex fence piles ground beam

The left and right wings of the upper tier retaining wall received significant horizontal displacements (**1000-1200 mm and more**), which caused the reinforced concrete ground beam destruction by **vertical cracks** with the widths of **up to 50 mm** due to retaining walls continuous horizontal movements and the emergency situation occurrence.

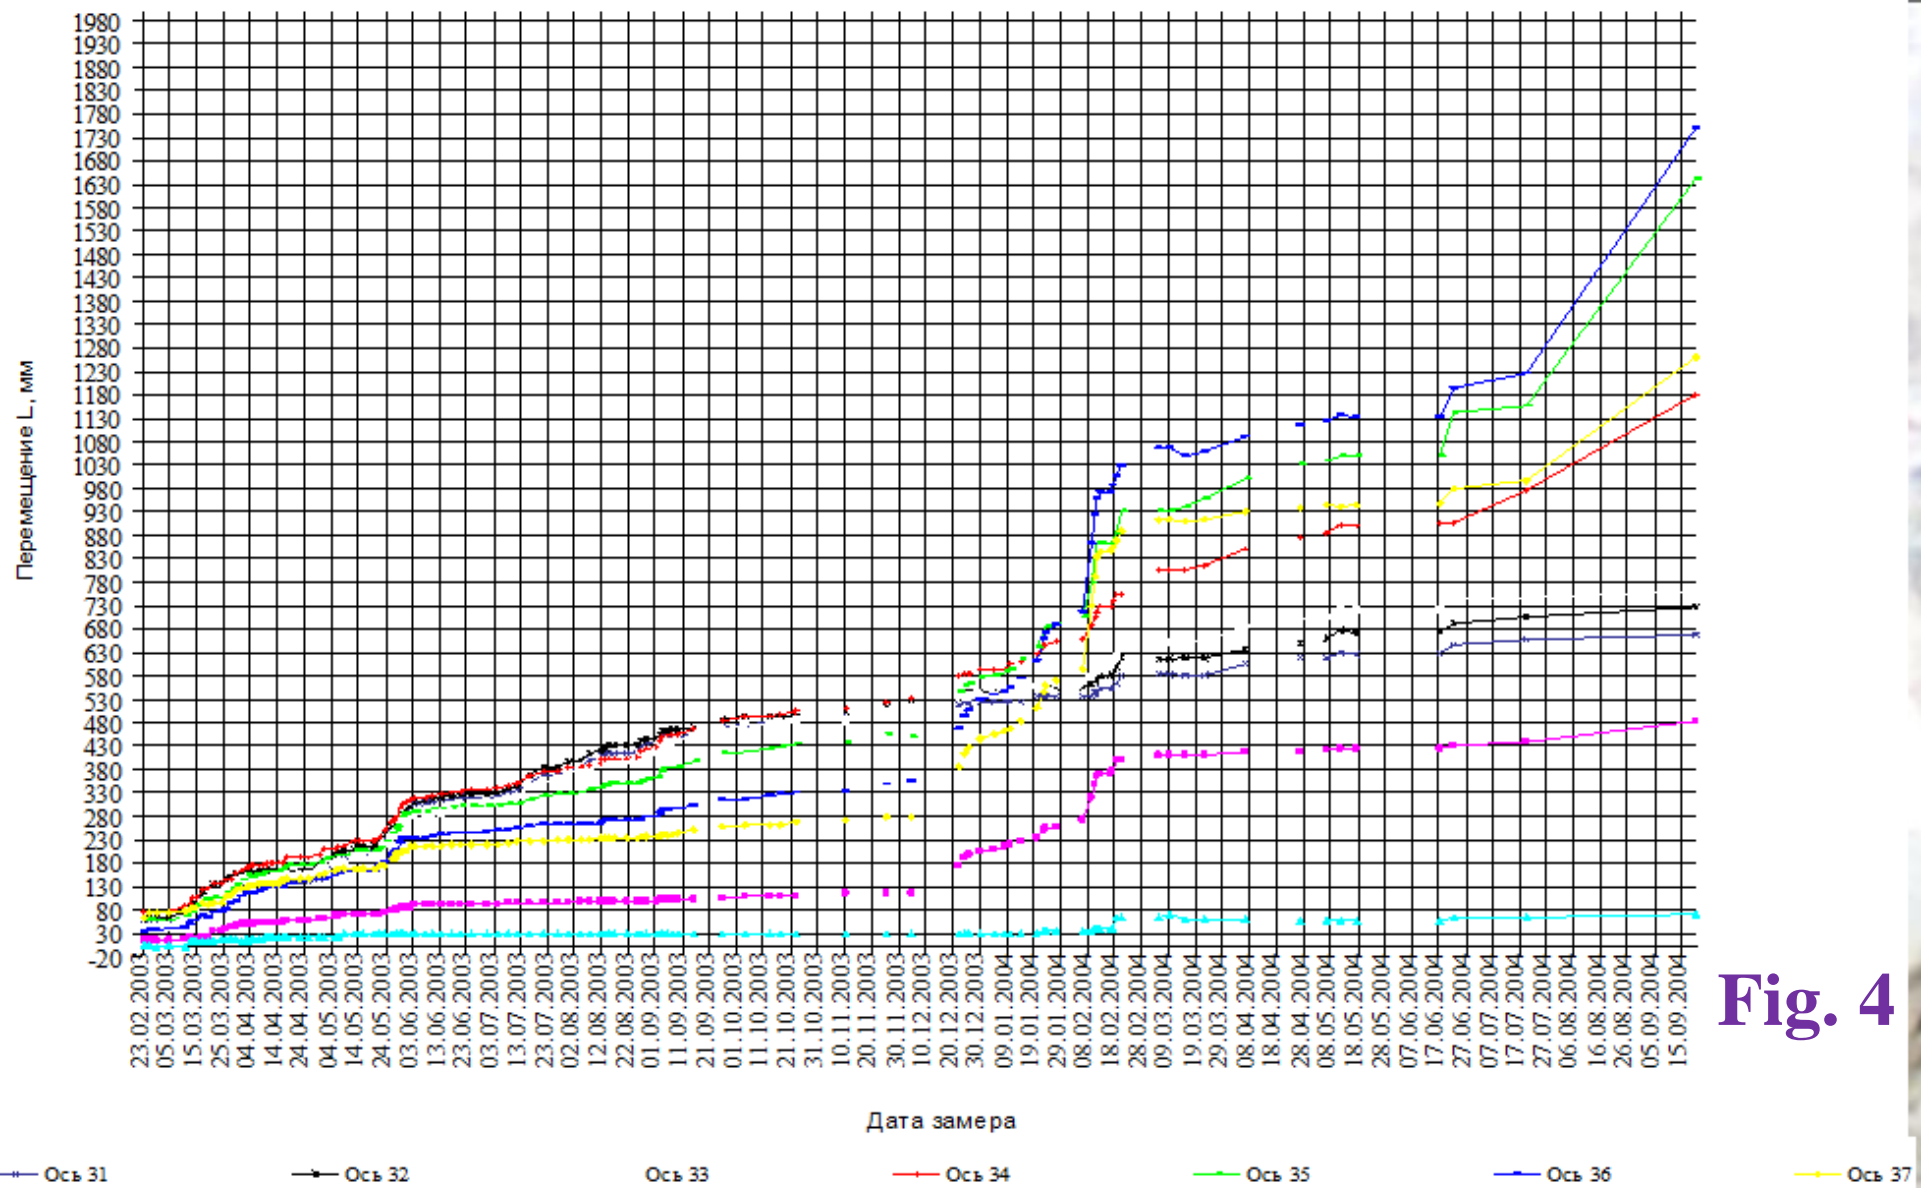
2. In Fig. 4 the horizontal movements of the ground beam top along the Y axis in the period from 23.02.2003 to 20.09.2004 are shown according to engineering and geodetic observations in the 31 ... 37 axes. The similar results are received in the 1 ... 30 axes.

The ground beam horizontal deformations during the reporting period constantly increased and had the maximum value of 1350 mm along the 7 axis, 1409 mm along the 8 axis, 1359 mm along the 9 axis, 1310 mm along the 10 axis, 1180 mm along the 34 axis, **1642 mm** along the 35 axis, **1750 mm** along the 36 axis and 1260 mm along the 37 axis.

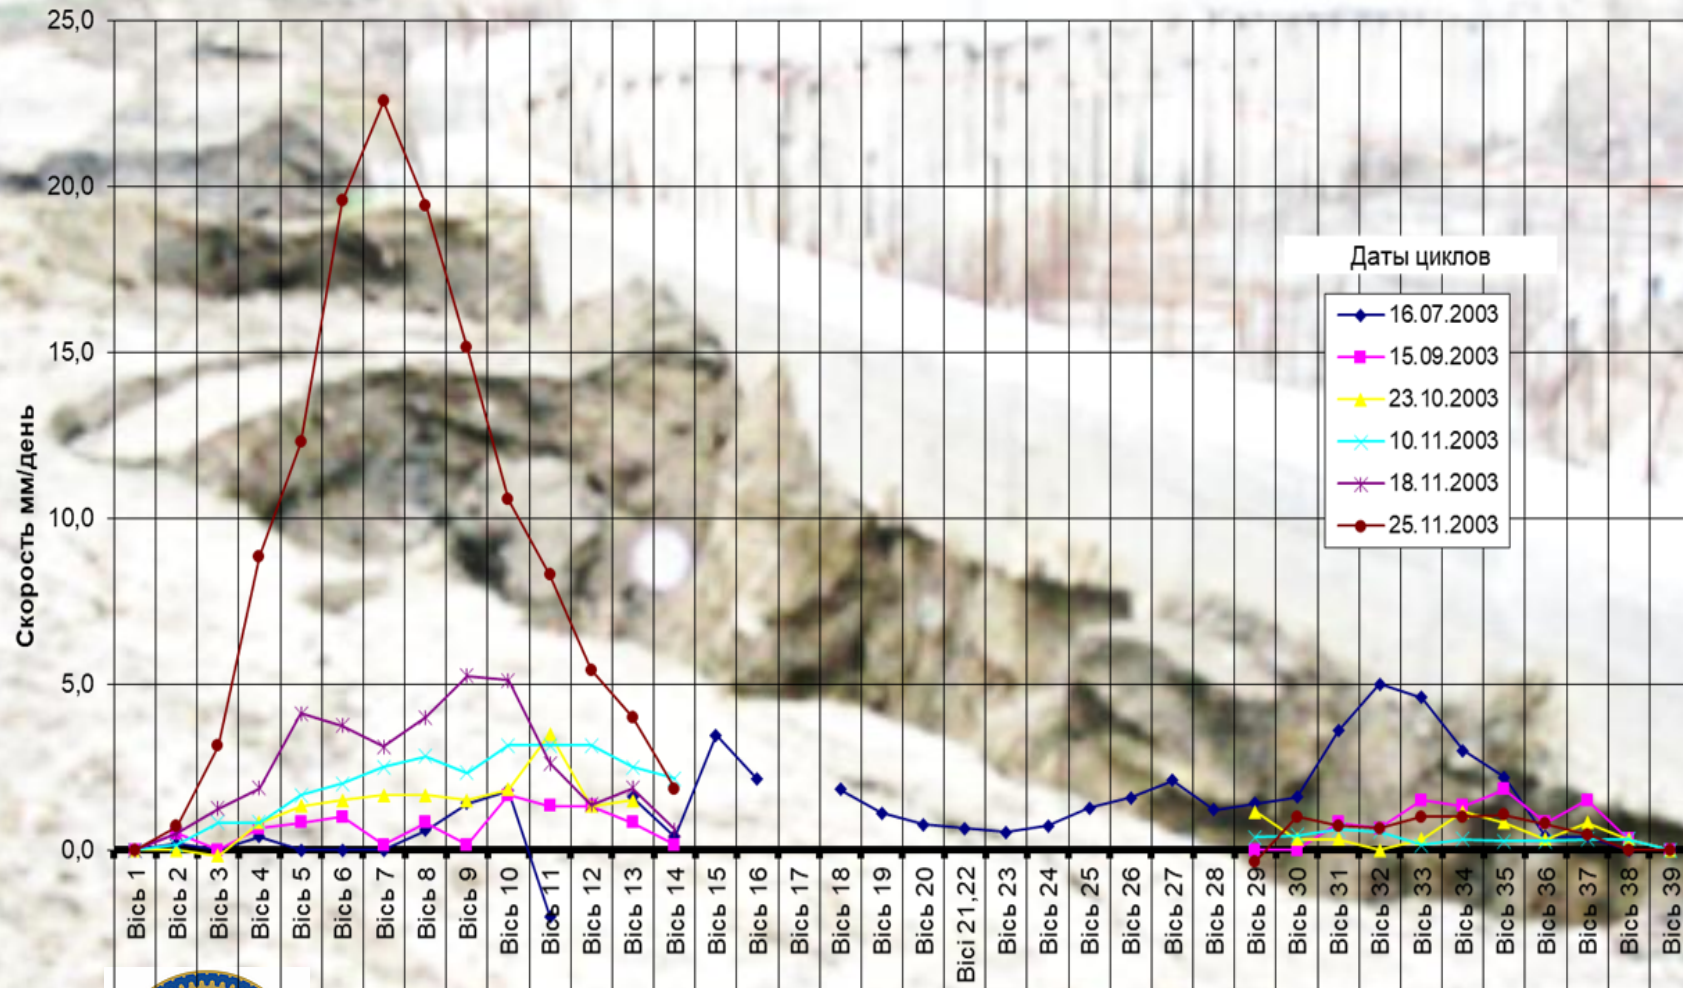
3. In Fig. 5 the diagram of the retaining structure ground beam movement velocity along the Y axis in the period from 16.07.03 to 25.11.03 is shown.

Скорость перемещения ростверка по оси У во времени

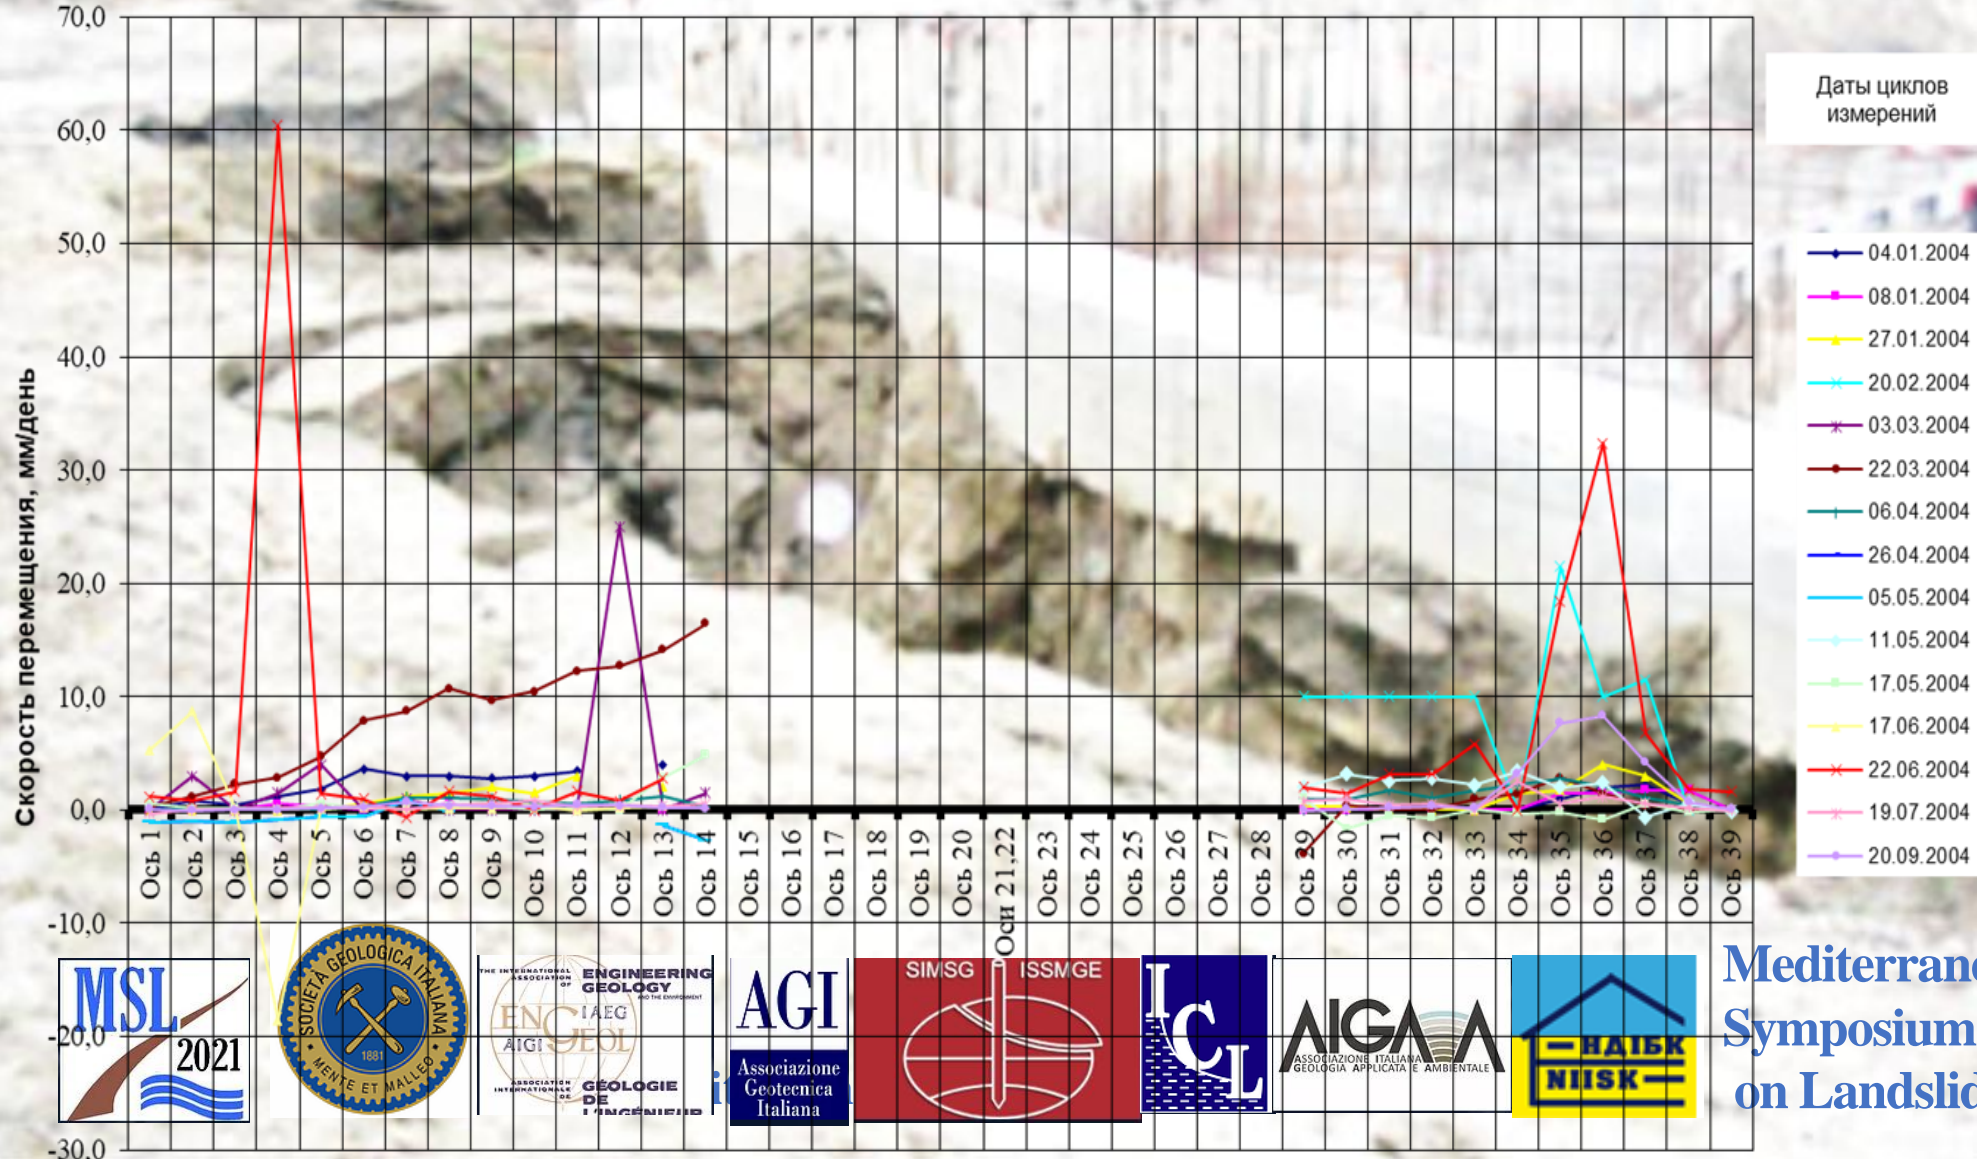
4. In Fig.6 the diagram of the retaining structure ground beam movement velocity along the Y axis during the period from 04.01.04 to 20.09.04 is shown.

Скорость перемещения ростверка по оси У во времени

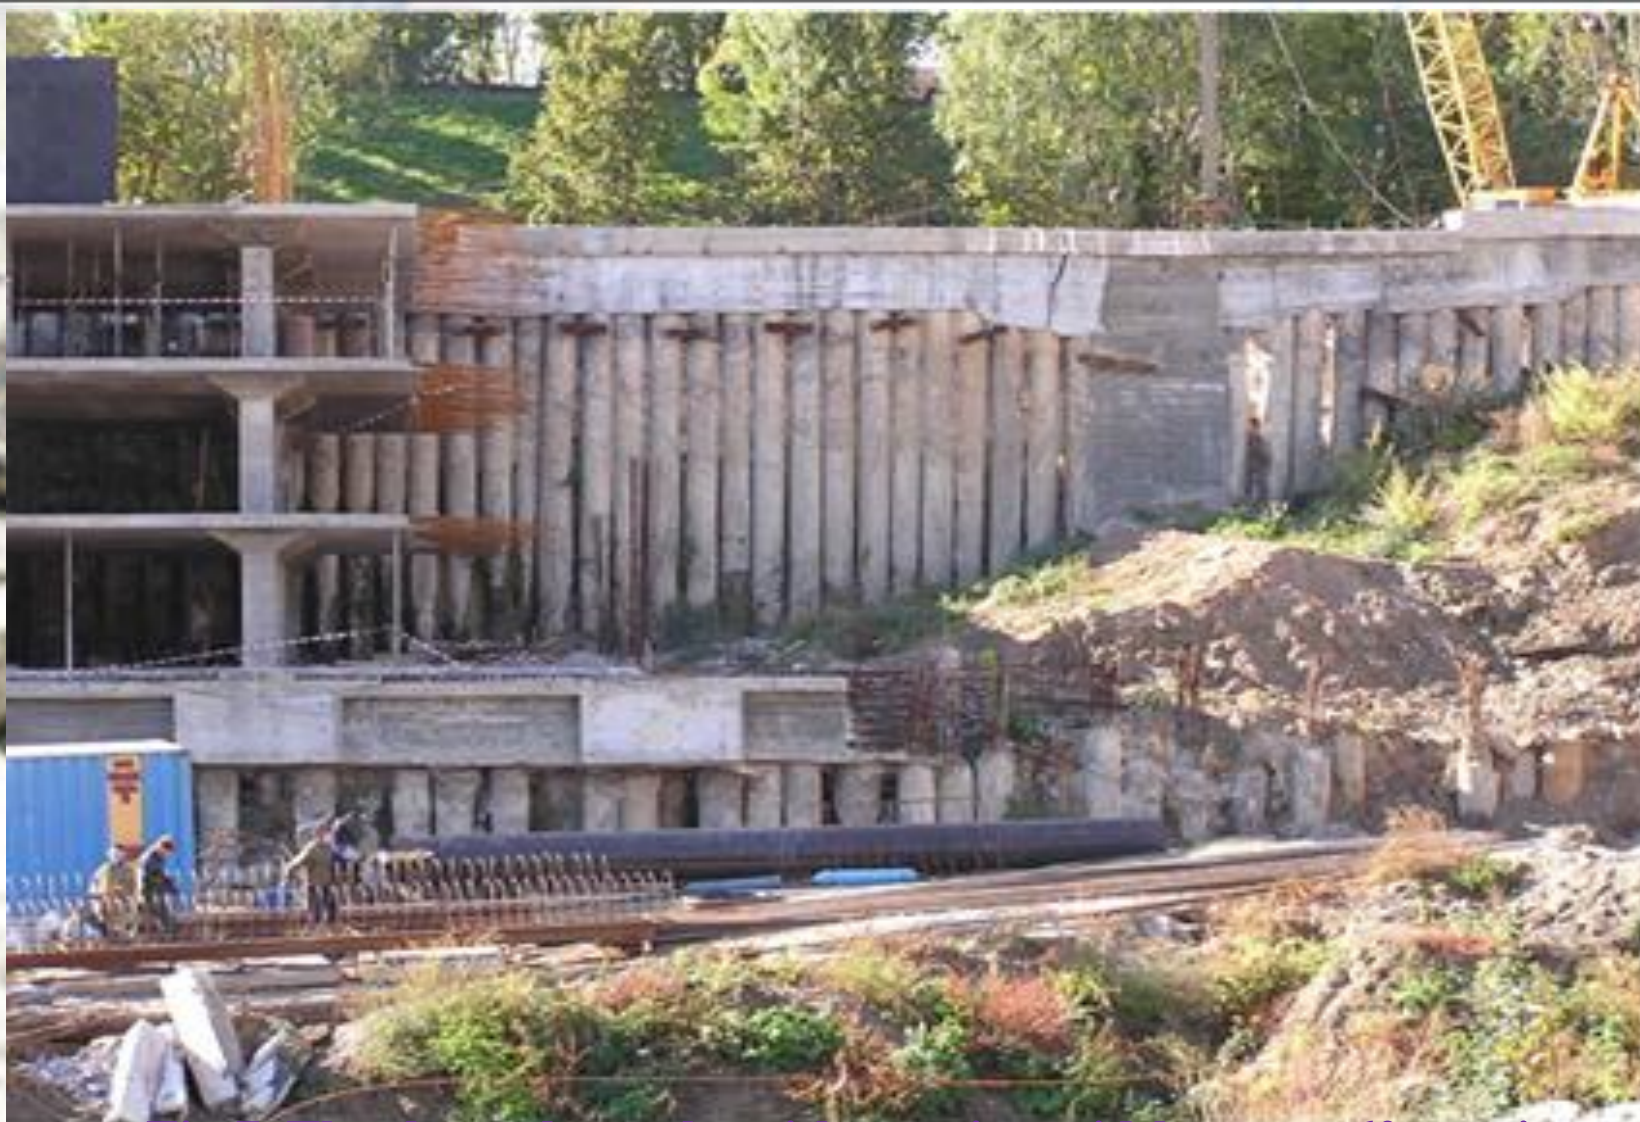
Fig.7. The through cracks with opening widths up to 60 mm in a fence pile ground beam along the Y axis in the 35 ... 37 axes as of

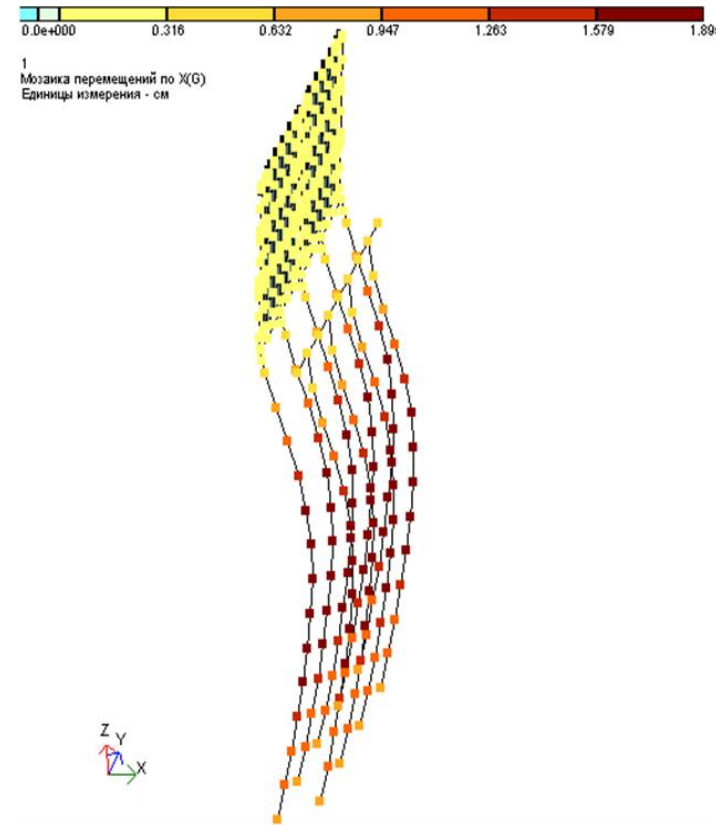
The maximum value of horizontal deformations at the pile nodes (Fig. 9) is 1.9 cm.

Fig. 9. – The deformed scheme of the calculation model nodes along the OX axis

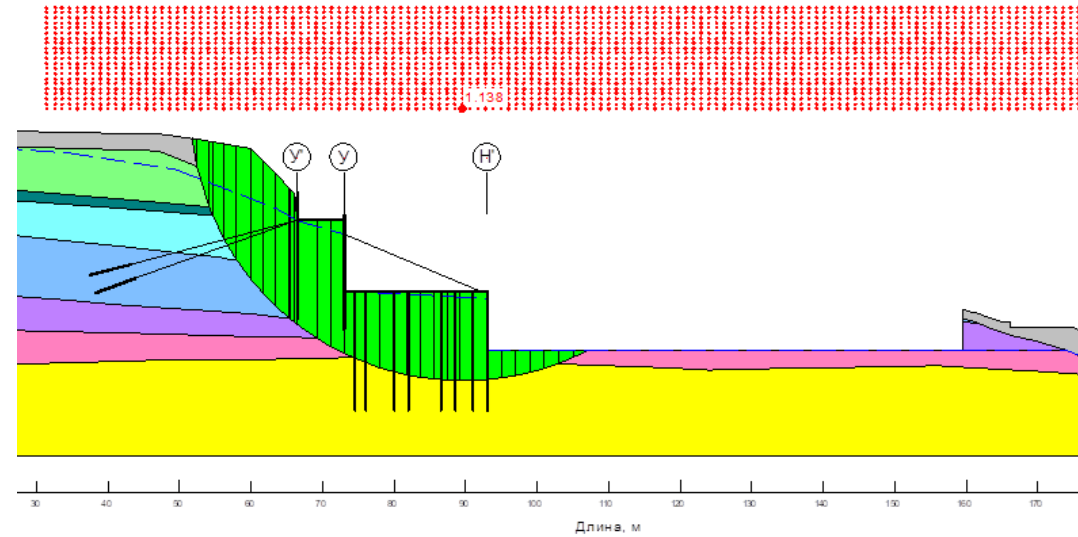
Fig. 11

The most probable sliding surfaces and the stability coefficient values for this slope portion are shown in figures 11 and 12.

2. Carried out numerical studies show that the additional structure along the Y axis at the top of pile row of soil anchors with a 60-t working tension can stop the ever-increasing slope soil deformations with its stability coefficient of [1.351; 1.354].
